Manhole Inspection Summary

Manhole # S31II_005MH

Location Address: **1426 MOSHER ST**

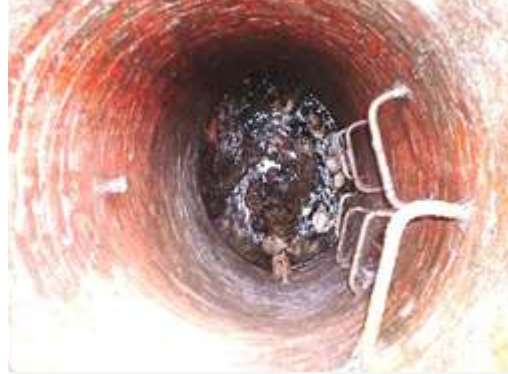
Top View

Corroded steps. Channel debris.

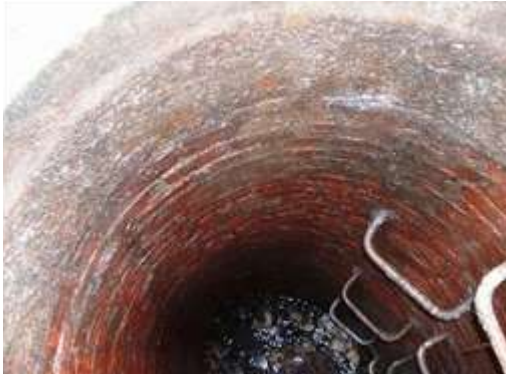
Defect

Frame leaks. Adjustment and Barrel infiltration.

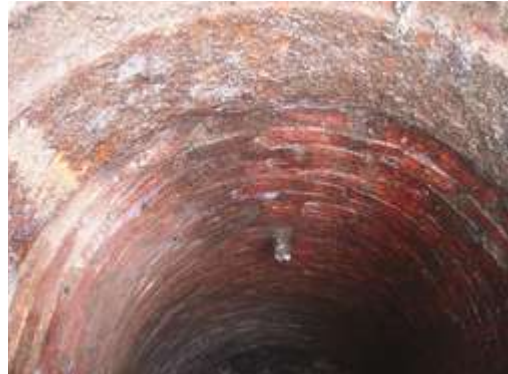
Defect

Frame leaks. Adjustment and Barrel infiltration - other side.

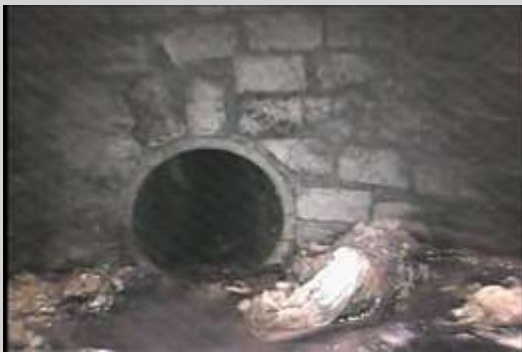
8 in. Circular Gravity Sewer Pipe Out @ 12 O'Clock

Deposits: ☐ None ☒ **Mud** ☐ Sludge ☒ **Debris** ☒ **Grease**

Silt Depth: **0.5** (in.) Deposits Extent: **Light**

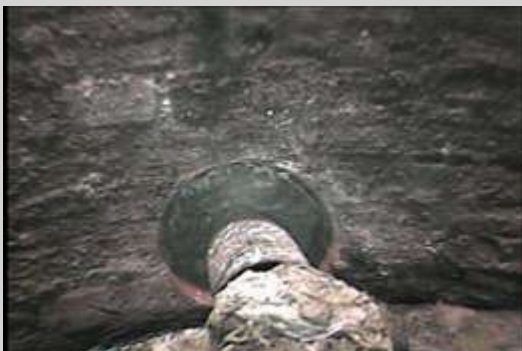
4 in. Circular Gravity Sewer Pipe In @ 6 O'Clock

Deposits: ☐ None ☐ Mud ☐ Sludge ☒ **Debris** ☒ **Grease**

Silt Depth: **4** (in.) Deposits Extent: **Heavy**
